**Flood Control Project Maintenance
Levee Inspections
LMA District Cover Sheet
Spring 2010 Levee Inspection Results**

Tehama County Flood Control and Water Conservation District

Spring 2010 Levee Inspection Results

Levee Inspection Report By Mile - Spring 2010

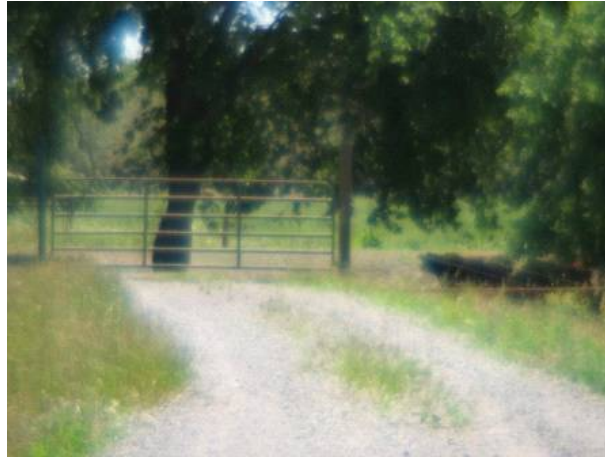
rduffey_s_20100616_048.jpg

Levee Mile Report Line	7
Start Levee Mile	3.64
End Levee Mile	3.64
Location	Crown
Category	Earthen Levee
Item	Encroachments

View of the non-permitted gate on the crown of the levee.

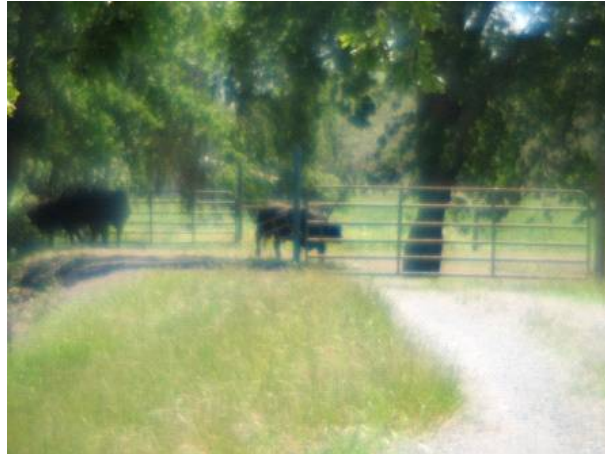
rduffey_s_20100616_049.jpg

Levee Mile Report Line	8
Start Levee Mile	3.74
End Levee Mile	3.74
Location	Crown
Category	Earthen Levee
Item	Encroachments

View of the nonpermitted gate and cowson the levee.

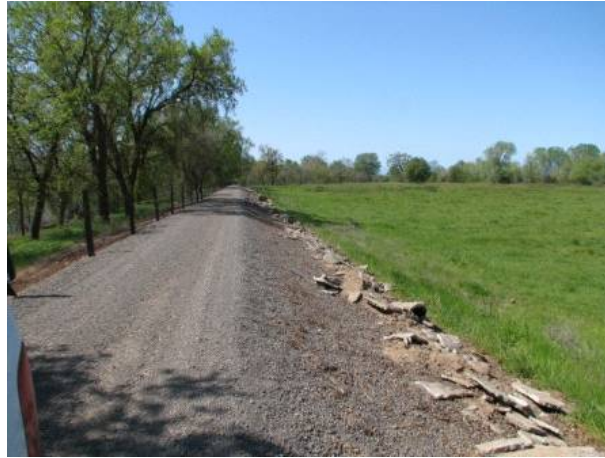
rduffey_s_20100616_050.jpg

Levee Mile Report Line	6
Start Levee Mile	1.01
End Levee Mile	1.30
Location	Land Side
Category	Earthen Levee
Item	Encroachments

View of the concrete that was placed along the slope of the levee.

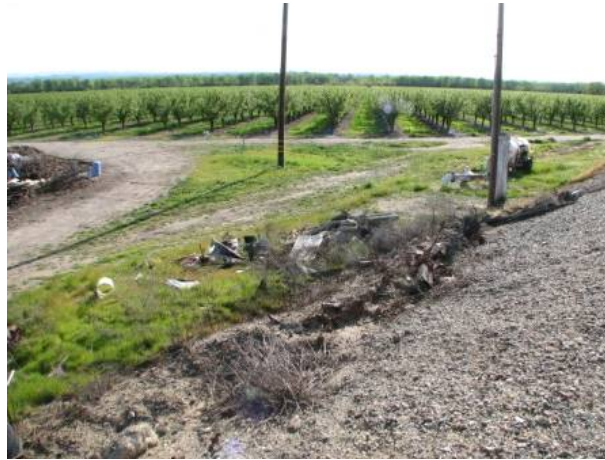
rduffey_s_20100616_051.jpg

Levee Mile Report Line	9
Start Levee Mile	3.34
End Levee Mile	3.34
Location	Land Side
Category	Earthen Levee
Item	Encroachments

View of the garbage and metal at the toe of the levee & along the slope of the landside.

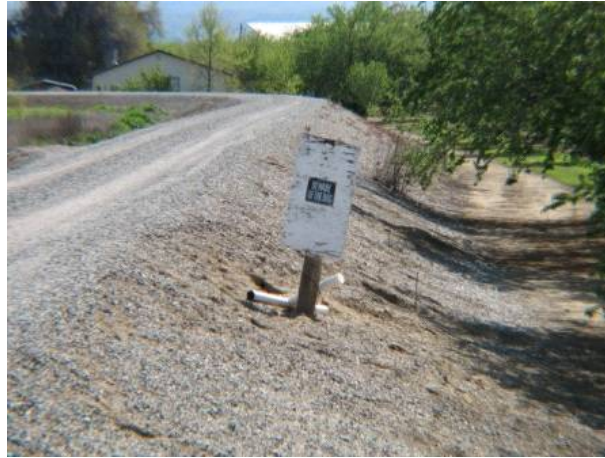
rduffey_s_20100616_052.jpg

Levee Mile Report Line	2
Start Levee Mile	2.57
End Levee Mile	2.57
Location	Land Side
Category	Earthen Levee
Item	Animal Control

View of the bait station next to the squirrel holes on the landside slope.

LMR No	Levee Mile		Category	Item	Location *	Rating **	Action/Comment	GPS Latitude/Longitude		Issue No. Photo
	Start	End						Start	End	
1	0.81	0.81	Earthen Levee	Encroachments	LS	M	Prunings	40.050683 ° -122.177573 °	40.050683 ° -122.177573 °	1
2	2.57	2.57	Earthen Levee	Animal Control	LS	M	Exterminate rodents and backfill and compact or grout burrows.	40.051675 ° -122.148122 °	40.051675 ° -122.148122 °	8 Y
3	2.70	2.76	Earthen Levee	Encroachments	LS	PO	Landscaping	40.051778 ° -122.145745 °	40.052243 ° -122.144825 °	2
4	2.97	3.07	Earthen Levee	Encroachments	WS	M	Prunings	40.054162 ° -122.142298 °	40.054725 ° -122.140552 °	3
5	3.13	3.13	Earthen Levee	Vegetation	WS	M	Elderberries are blocking visibility and flood fight capability.	40.055632 ° -122.138910 °	40.055607 ° -122.138868 °	11
6	3.37	3.84	Earthen Levee	Vegetation	WS	M	Elderberries are blocking visibility and flood fight capability.	40.056831 ° -122.136365 °	40.054862 ° -122.129279 °	9
